Manhole Inspection Summary

Manhole # S57G__017MH

Location Address: **3925 bank st**

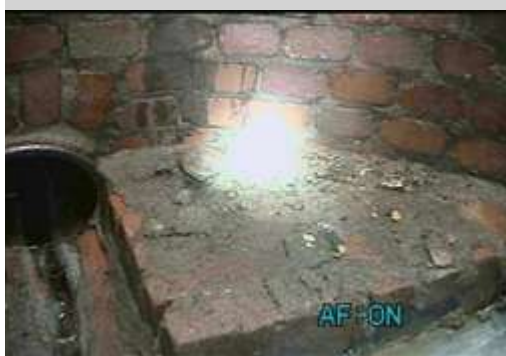
Misc

bench debris

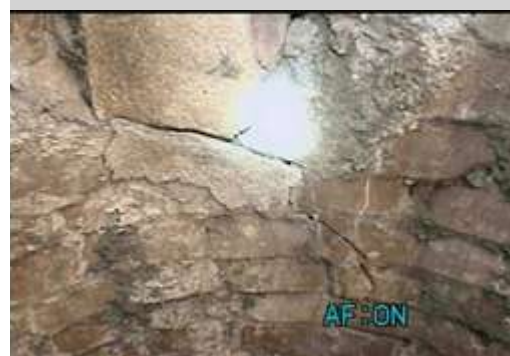
Defect 3

Condition: ☐ Sound ☒ **Cracked** ☐ Root Intrusion ☐ Loose Brick ☐ Deteriorated

cracked corbel

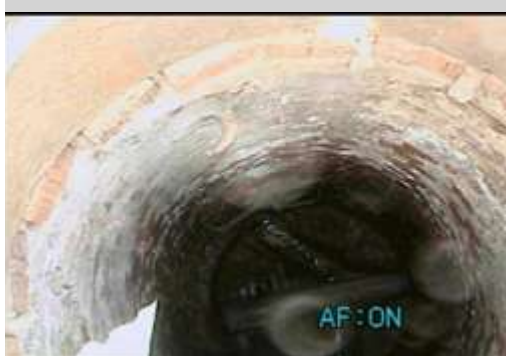
Defect 2

Count: **6** Missing: **3** ☒ **Corroded**

☒ **Evidence Of Surcharge** Depth: **8.** (ft.) ☐ Active Surcharge Present

corroded and missing 3 steps and evidence of surcharge

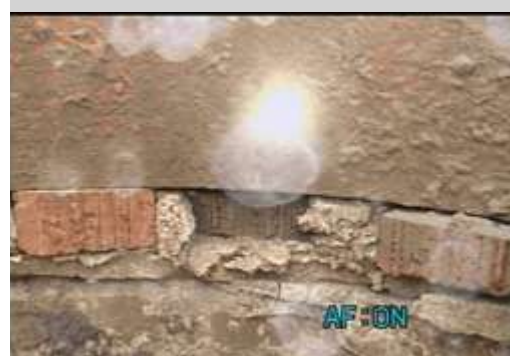
Defect 1

Condition: ☐ Sound ☐ Cracked ☐ Root Intrusion ☒ **Loose Brick** ☒ **Deteriorated**

chimney cond loose bricks and deteriorated, frame adj

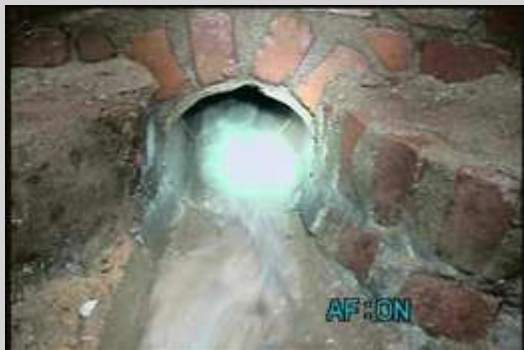
12 O'Clock Outflow

Pipe Height: **0** (in.) Direct
Pipe Material: **Clay** ☐ Pipe Lined
Invert Depth: **12.20** (ft.) Flow Characteristics: **Fast**
Deposits: ☒ None ☐ Mud ☐ Sludge ☐ Debris ☐ Grease
Silt Depth: **0** (in.) Deposits Extent:
Infiltration: **None** Pipe Seal Cond: **Unknown**

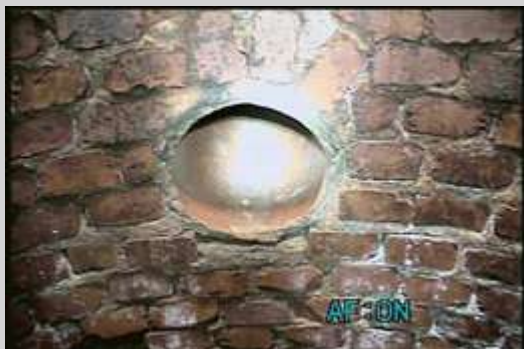
3 O'Clock Inflow

Pipe Height: **0** (in.) Direct
Pipe Material: **Clay** ☐ Pipe Lined
Invert Depth: **8.70** (ft.) Flow Characteristics: **Slow**
Deposits: ☒ None ☐ Mud ☐ Sludge ☐ Debris ☐ Grease
Silt Depth: **0** (in.) Deposits Extent:
Infiltration: **None** Pipe Seal Cond: **Unknown**

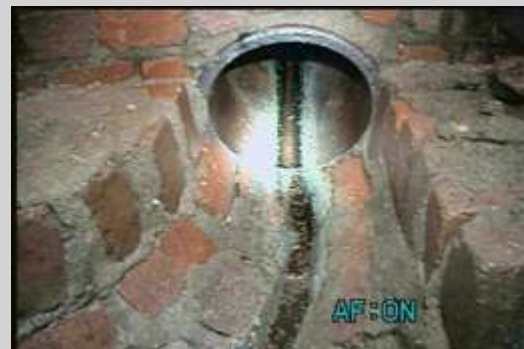
Drop In @ 3 OClock

Drop: **Outside Direct**

Drop Condition: **Open**

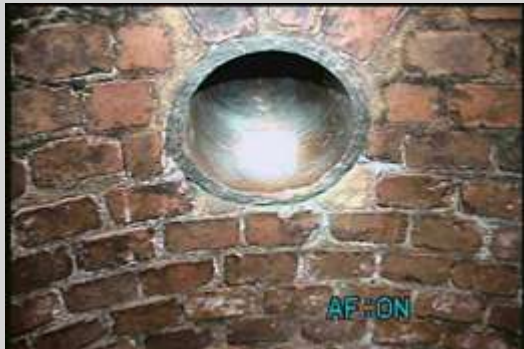
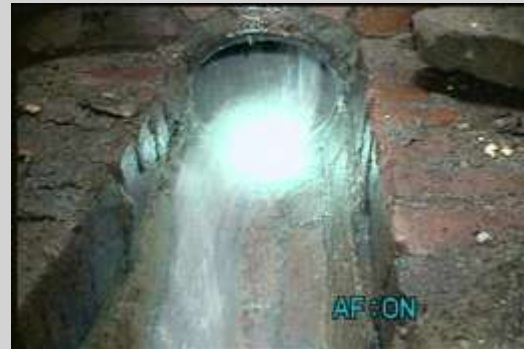
6 O'Clock Inflow

Drop: **Outside Direct**

Drop Condition: **Open**

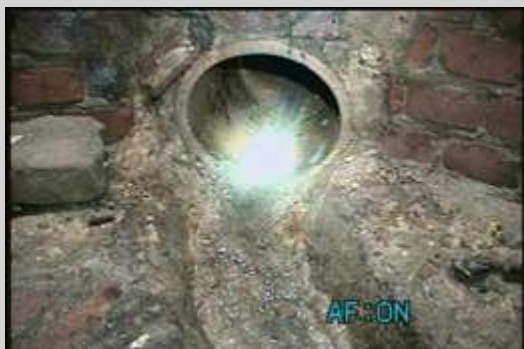
9 O'Clock Inflow

Connects To: **Dead End**
